Intel[®] Pentium[®] III Processor Specification Update

Release Date: January 2007

Document Number: 244453-056

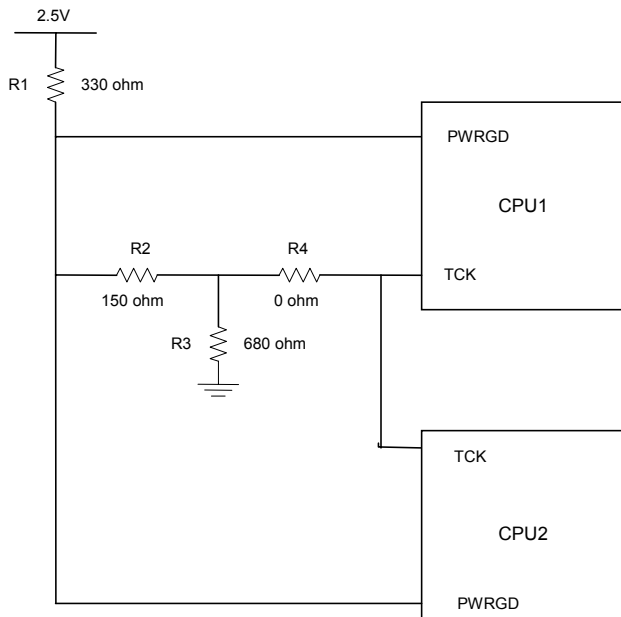
Pentium® III Processor with 512KB L2 Cache Platforms Workaround

In addition, the example workaround circuits shown do not support production baseboard test methodologies that require the use of the processor JTAG/TAP port. Alternative workaround solutions must be found if such test capability is required.

Assumes the inputs to the CPU_PWRGD are open collector signals that are Wire-ANDed together

- The example workaround circuit assumes that the PWRGD inputs into the processors are open collector. Tying the PWRGD inputs together in a Wired-AND fashion allows each processor to receive PWRGD at the same time but at the latter of the 2 separate PWRGD assertions. If separation of the PWRGD inputs to each processor is required, extra circuitry will be required.
